# GAMMA-RAY INSPECTION OF POST TENSIONING CABLES IN A CONCRETE BRIDGE

Mário Pimentel & Joaquim Figueiras  
LABEST  
University of Porto, Faculty of Engineering  
Porto, Portugal  
[mjsp@fe.up.pt](mailto:mjsp@fe.up.pt)

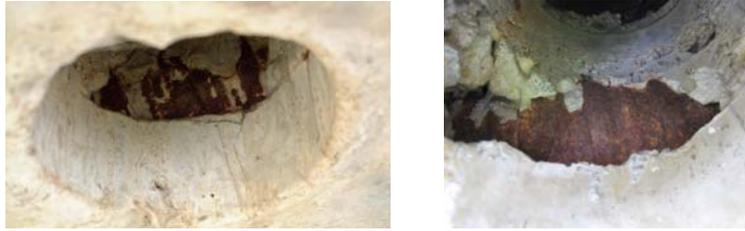
Besides minor signs of corrosion in confined areas, mainly related with drainage problems of the deck, and some stirrups not properly protected by an adequate concrete cover, the main concern is related to the state of the embedded prestressing tendons. The holes allowing the movable scaffolding attachment to the deck were not filled with concrete and, in some of them, it is possible to observe corroded metallic ducts containing the bottom continuity tendons, as depicted in Fig. 3. It is also known that, at the time of the construction, the injection of the ducts was a problematic issue and it is likely that it was not properly executed. As these ducts were locally exposed during 27 years, the state of the prestressing tendons is, at the present time, unknown.

Fig. 3 - Prestressing ducts exposed at the bottom slab.

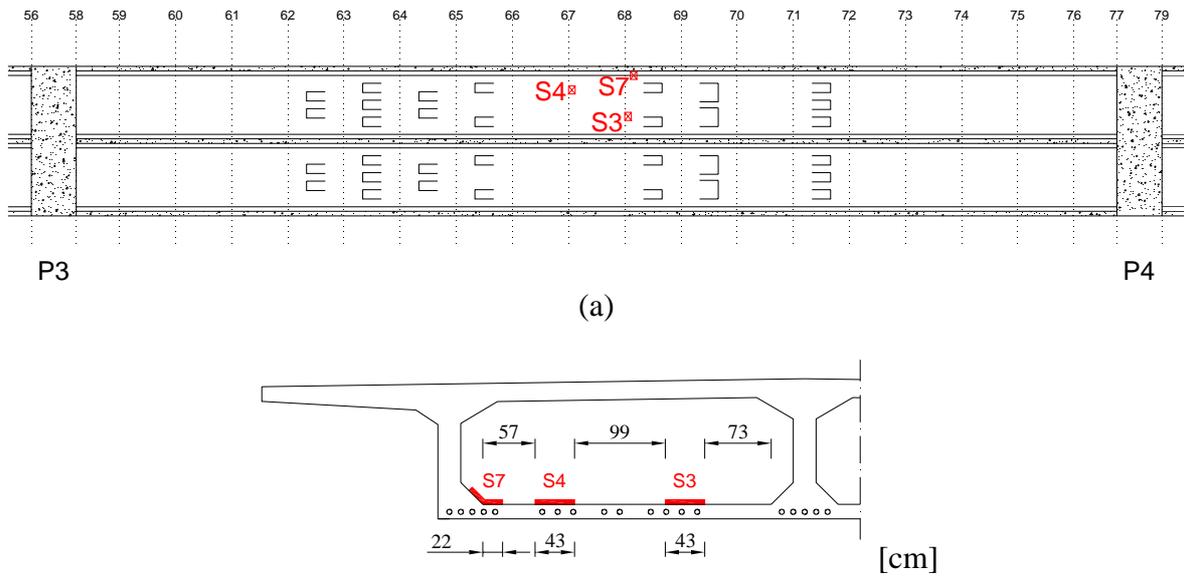
Fig. 5 - Sectors where measurements were taken: (a) sectors 3, 4 and 7 in the bottom slab of the 4th span; (b) corresponding positioning in the box-girder with the expected cables location.

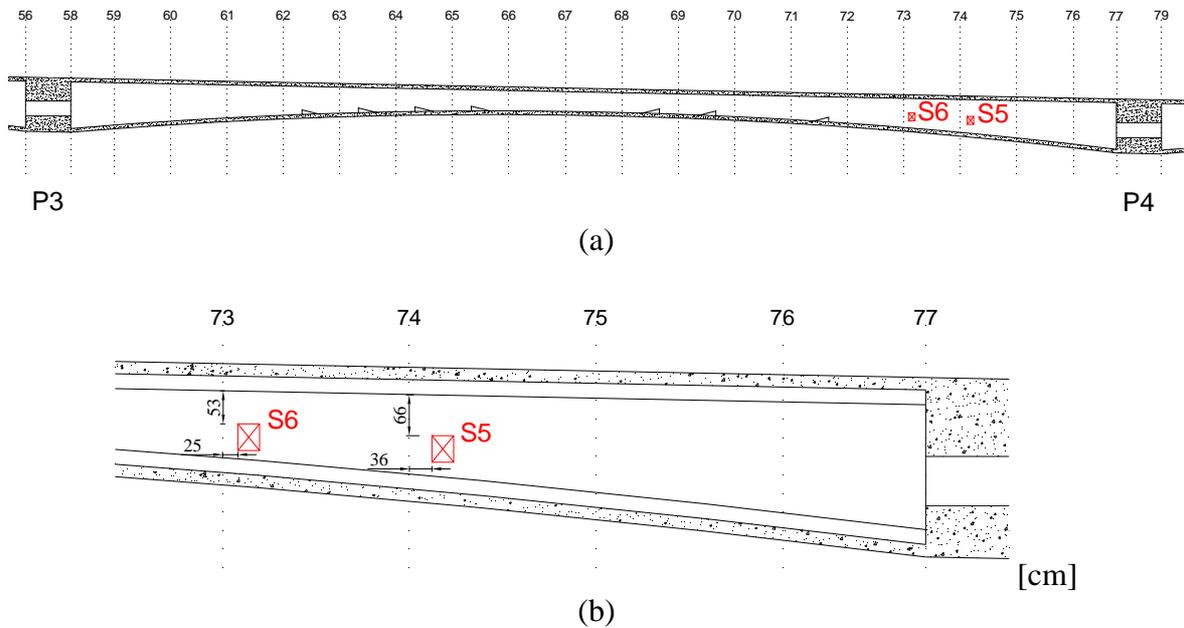
Fig. 6 - Location of the sectors where measurements were taken: (a) sectors 5 and 6 in the central web; (b) corresponding positioning in the box-girder.

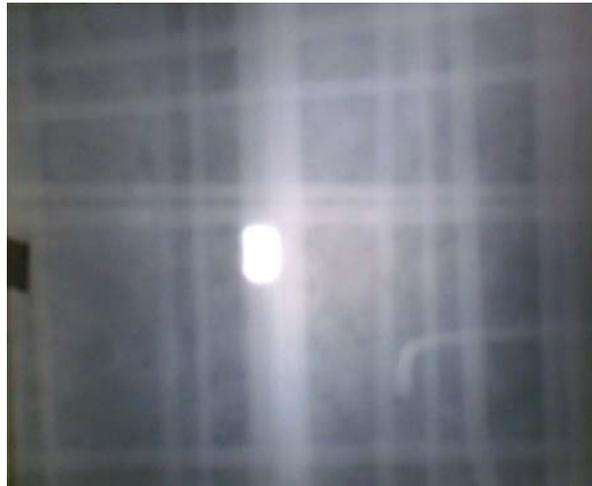
In all the 7 gammagraphies no grouting defects were observed nor signs of wire breaks or section loss due to corrosion. According to the THASA report [3] where the quantitative analysis of the obtained gammagraphies is performed, the ducts have 55 mm diameter and the strands were confirmed to be 0.5". Regarding the number of strands per duct, not all the strands could be identified due to their relative positioning in the duct. In Fig. 8 the gammagraphy corresponding to sector S3 is depicted. Three tendons can be identified together with upper and bottom reinforcement grids. In Fig. 9 the gammagraphies of the web sectors are depicted and cantilever tendon is identified in each gammagraphy. The bright rectangle near the centre of the gammagraphies corresponds to the image of an external element used for ID purposes.

Fig. 8 - Gammagraphy of sector S3

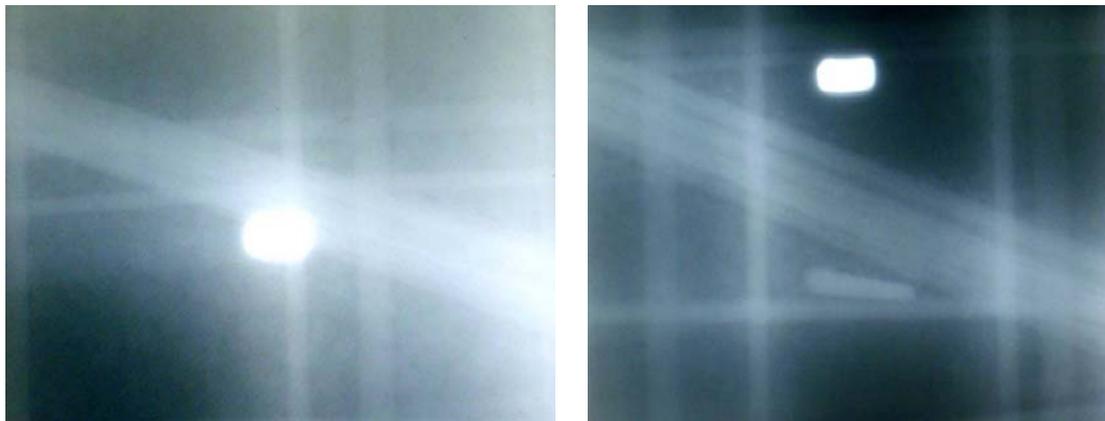
(a) Sector S5

(b) Sector S6

Fig. 9 - Gammagraphies of the web sectors.
