Gamma-ray imaging for void and corrosion assessment in PT girders

M.A.J. Mariscotti^a, F. Jalinoos^b, T. Frigerio^a, M. Ruffolo^a and P. Thieberger^a

Abstract

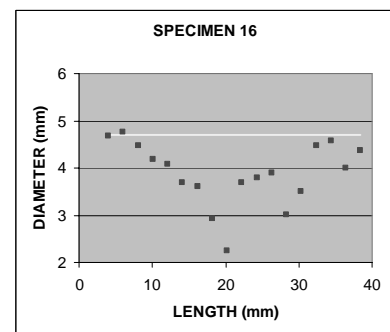
The upper part of Fig. 1 shows the gammagraphy of a corroded rebar [5]. The effect of corrosion in a rebar is to change metal into oxide, the latter being of less density. The absorption of gamma rays, being sensitive to density will show the loss of metal in a gammagraphy as a change of rebar diameter. Since the amount of corrosion varies along the rebar length, the phenomenon is seen in a gammagraphy as a change of diameter at different sections.

The plots in Fig. 1 show the edge pixel positions in terms of distance to the “average center” of the bar (upper plot) and their differences (lower plot), along the length of the bars.

The data in the lower plot correspond to the defects in the projected diameters relative to the expected value (white straight line). The accuracy of this measurement is estimated at 0.3 mm.

Fig. 1. Gammagraphy of a corroded bar in a concrete block [5]. The plots show the edge pixel positions in terms of distance to the “average center” of the bar and their difference, along the length of the bars.

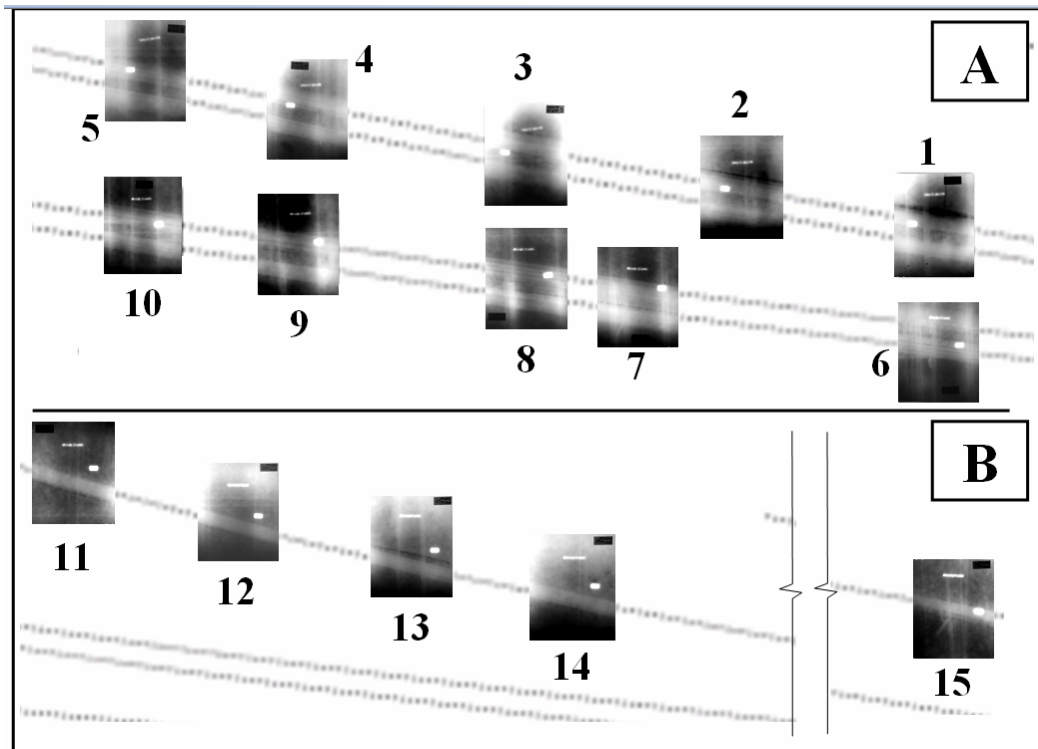
Fig. 5. Overview of the gammagraphies obtained in this work. Frame B corresponds to the right part of the girder (see Fig. 4). As discussed in the text, gammagraphies 1, 2, 3 and 13 exhibit defective grouting, most notably in 1.

Fig. 5 gives an overview of the 15, 35 x 43 cm (14"x 17") gammagraphies obtained in this work and Fig. 6 exhibits enlargements of four of these gammagraphies for the purpose of the following discussion.

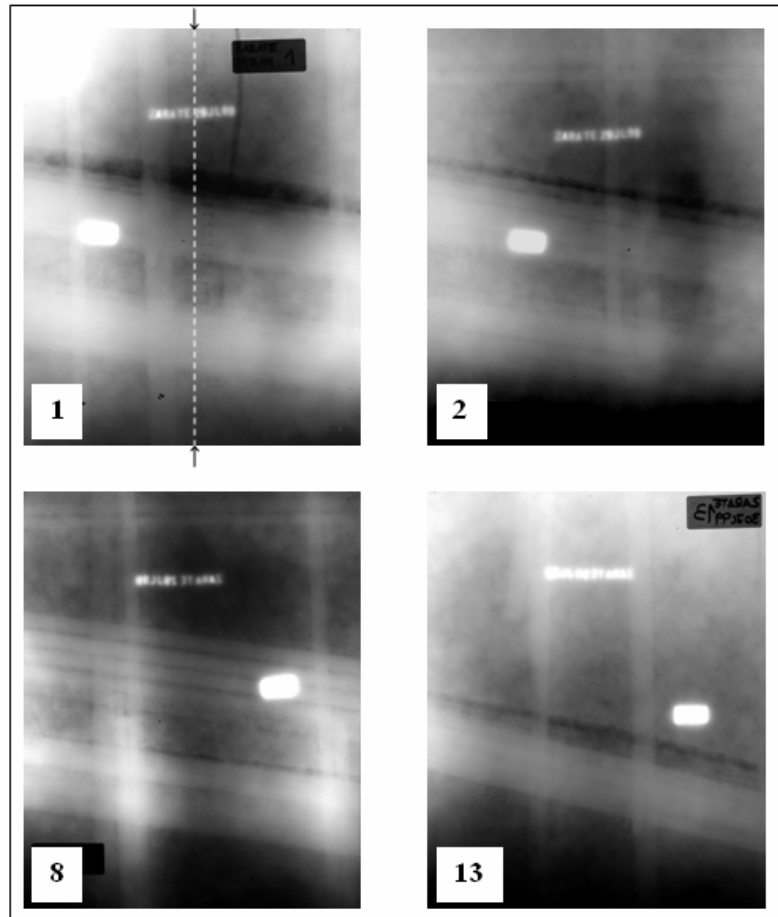
Fig. 6. Illustrative examples of the measurements carried out in Zárte bridge. Gammagraphy 1 shows a severe case of void in the grouting of the upper duct. In 2, which is the next gammagraphy towards one of the ends of the girder, this defect is still present but diminished. In the upper duct in 8 the different bundles of wires can be appreciated and in both the lower duct of 8 and upper duct of 13 thin black lines show slight voids. These gammagraphies also show stirrups as white vertical bands. The cables and ducts diameters are ~2" and 3", respectively.

Gammagraphy 1 shows a severe case of void in the grouting of the upper duct. In 2, which is the next gammagraphy away from the center of the girder, this defect is still present but less marked than in 1. Also minor voids in the upper part of ducts in gammagraphies 8 and 13 are discernible.

In the other gammagraphies shown in Fig. 6 no steel thickness deficiency signaling corrosion has been observed beyond the measurement uncertainty of 0.3 mm.

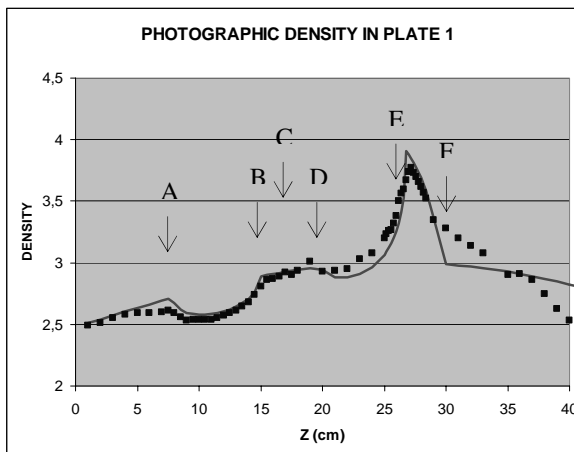
Fig. 7 shows the photographic density along the vertical dotted line in Fig. 6 (plate 1). The coordinate Z goes from the bottom up in the gammagraphy as shown in Fig. 6. “Valleys” in this plot at $Z \sim 10$ and 22 cm correspond to the lower and upper ducts, respectively and the peak at ~ 27 cm correspond to the void in the grouting of the upper duct.

Fig. 7. Photographic density along dotted line in plate 1. A-B: lower cable; A-C lower duct; D-E: upper cable; D-F: upper duct (see Fig. 6)

These data were fitted (gray line) to the mathematical expression that describes the experimental arrangement used in these measurements: Gamma-rays from an ^{192}Ir source at 60 cm from the plate traversing a 2.5 g/cm^3 concrete block with two 7.2 cm internal diameter ducts in the center of the block, both with 5.2 cm diameter cables inside. The only significant adjustable parameters in this calculation were: the grouting density in the upper duct (0.3 g/cm^3) and the density of both cables (set to 3.5 g/cm^3). The grouting density in the lower duct was assumed equal to that of concrete.

The following conclusions can be drawn from these results: a) At the maximum photographic density, the depth of the void is a little more than 6 cm equivalent to about 5 cm of air since the fitted density in this volume is 0.3 g/cm^3 ; b) Considering that the maximum density of a cable composed of bundles of steel wires is about 80% of steel density, then the fitted density of 3.5 g/cm^3 indicates that the cables packing factor is about 55% ; c) The difference between calculated and measured values at $Z \sim 25$ cm corresponds to a steel thickness deficiency in the top wires of the upper duct of up to 7 mm.
