# GAMMA-RAY INSPECTION OF POST TENSIONING CABLES IN A CONCRETE BRIDGE

Mário Pimentel & Joaquim Figueiras  
LABEST  
University of Porto, Faculty of Engineering  
Porto, Portugal  
[mjsp@fe.up.pt](mailto:mjsp@fe.up.pt)

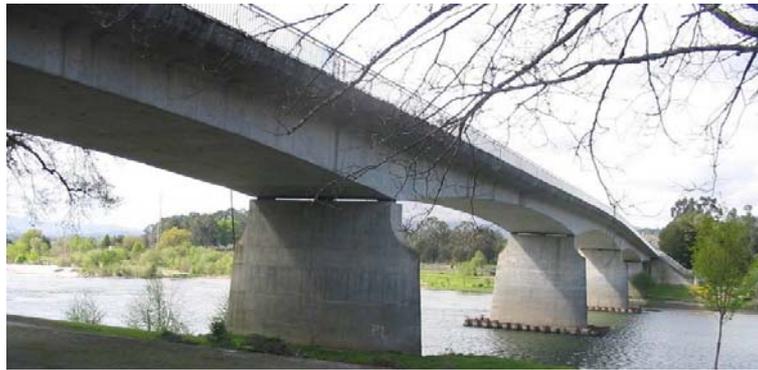
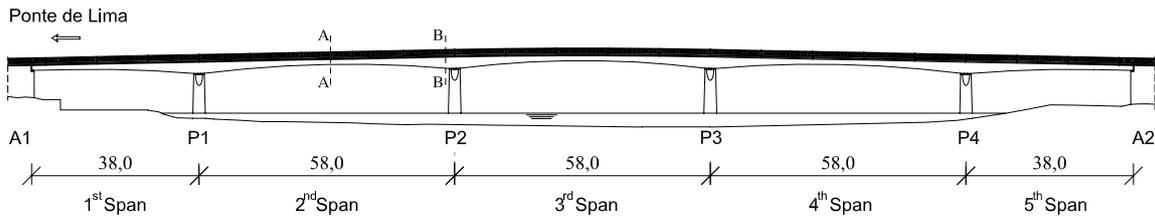
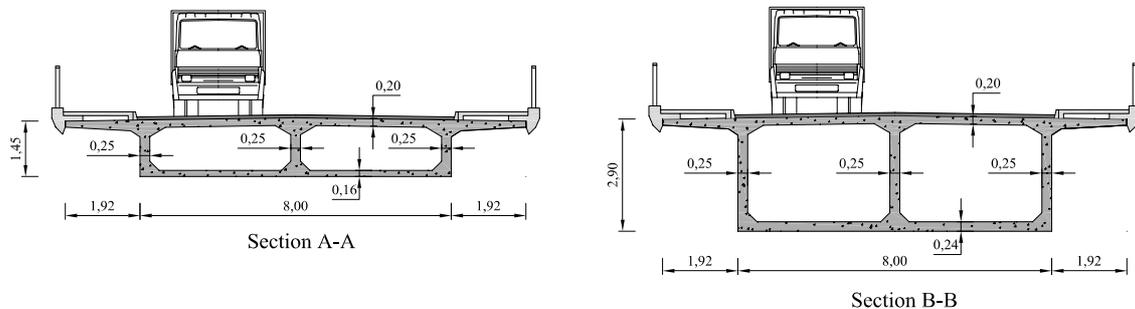
Fig. 1 - N. S. da Guia Bridge: (a) view of the bridge; (b) side elevation and notation; (c) typical cross-sections.

The N. S. da Guia Bridge (Fig. 1) is a prestressed concrete bi-cellular box-girder bridge with a total length of 250m, divided by 5 spans of 38-3x58-38m. The cross-section height varies parabolically from 1.45m at the spans to 2.9m at the intermediate supports with a resulting slenderness ranging between  $L/40$  and  $L/20$ . The deck is 11.84m width supporting one carriageway with two traffic lanes and being supported by laminated neoprene bearing pads which rest on lightly reinforced concrete piers. This was one of the first bridges designed and built in Portugal according to the segmental cantilever construction method. Although the original design dates back to 1973, the construction only began in 1978 and the bridge was opened to traffic in 1980. This bridge is located in the national road EN 201, which was once part of the main route connecting the Spanish region of Galicia with the North-western part of Portugal. In 1998 a new motorway connecting these two regions was opened and nowadays the bridge is crossed mainly by local traffic.

During a routine inspection several cracks were detected in the webs which were not reported in previous inspections. A comprehensive examination program was developed aimed at evaluating: the causes of the observed cracking patterns; the current safety level of the bridge, and; the urgency of eventual strengthening actions. As part of this program, a detailed visual inspection campaign was carried out enabling a complete mapping of the cracking patterns and other anomalies of the bridge deck. Both internal and external inspections were performed. Consistent cracking patterns were observed in the webs and in the bottom slab, exhibiting both longitudinal and transversal symmetry, as depicted in Fig. 2. The bridge was monitored both during a load test and under normal serviceability conditions during a period of one week. Although the cracks exhibited opening a closing movements, no significant deviation could be observed from the calculations performed using a linear elastic model considering uncracked concrete behaviour [8]. In a limited number of predefined locations, a covermeter was used to check if the reinforcement layout coincided with the prescribed in the original design. The agreement was found to be good. Only the most superficial reinforcements, and not the post-tensioning ducts, could be detected with this method. The concrete strength was evaluated by combining the results of NDT methods (sclerometer test and ultra-sounds) with a limited number of tests on drilled cores.

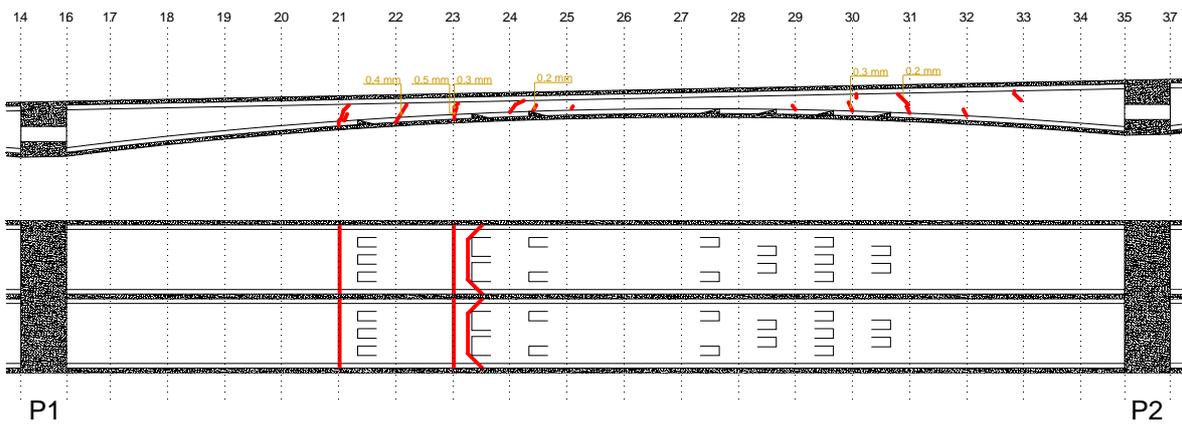
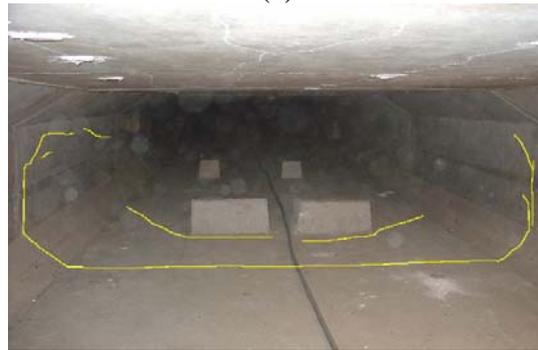
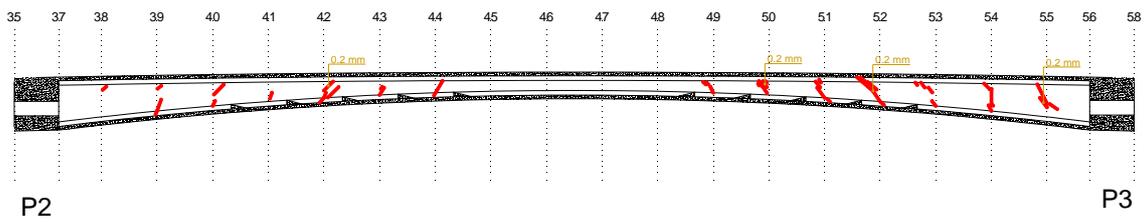
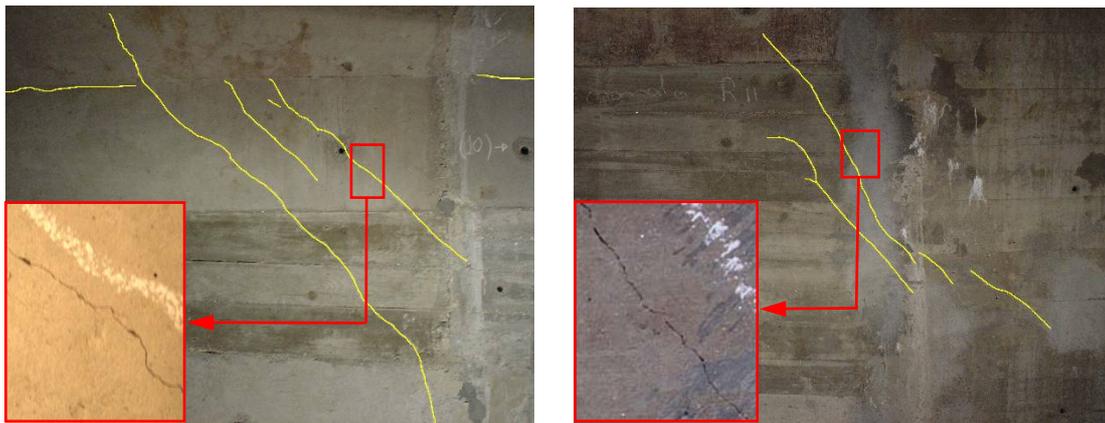
Fig. 2 -

- Apart from the bottom slab continuity tendons, the anchorages are not visible and accessible to confirm the assumptions that inevitably had to be made;
- A close observation of the formwork marks on the concrete surface inside the box-girder and the information contained in the construction log book reveal that the construction sequence defined in the original design was not strictly followed. Therefore, the prestressing forces calculated in the original design may not constitute a reliable basis;

- The use of precast concrete segments was defined in the original design. In these circumstances the time dependent alteration of the sectional forces due to concrete creep is lower than in the adopted in-situ segmental cantilever construction method. It was unclear if a re-calculation of the bridge had been made in order to account for the different construction sequence and procedure.

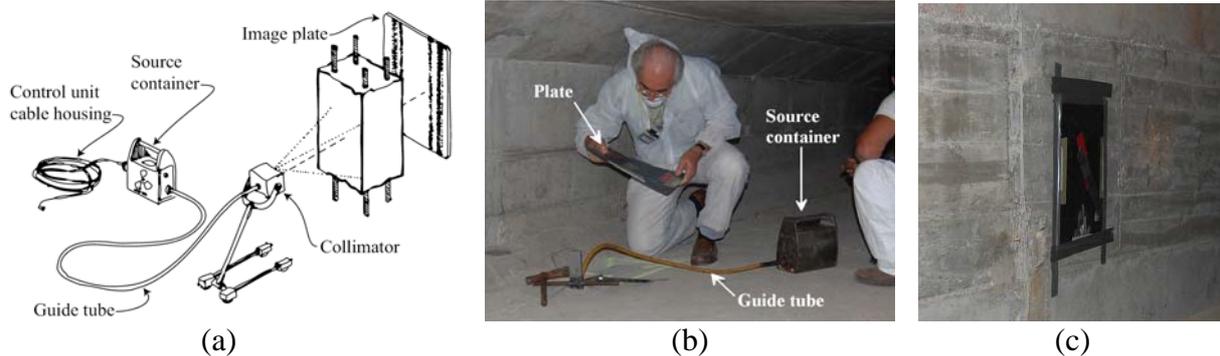
Fig. 4 - Gamma-ray testing: (a) Schematic representation of a typical experimental arrangement (b) View of the source container, guide tube and image plate during the test; (c) plate positioned in the web.

In this study a radioactive  $^{192}\text{Ir}$  source with only 20Ci was used. The source is kept inside a special container with a Uranium shield. For performing an irradiation, the source is placed at the tip of the guide tube by remote control (Fig. 4). Conventional films were still used because no local provider for a CR system could be found. Therefore, the required exposure times led to the fact that only 7 gammagraphies could be taken in one working day, including the necessary time for their chemical development in the laboratory. The films were placed inside flexible cassettes which contained thin lead foils designed to improve image contrast by filtering the scattered radiation. Care was taken at all times to meet radiological protection and safety requirements in accordance to the International Atomic Energy Agency (IAEA) regulations. Acceptable radiation dose rates were achieved at a distance of approximately 10 meters. Outside the box-girder, dose rates well below the acceptable levels for general public were measured. It is to be noted that gamma radiation from radioactive sources induces no radioactivity on the irradiated elements nor produces any unwanted effects on these elements.

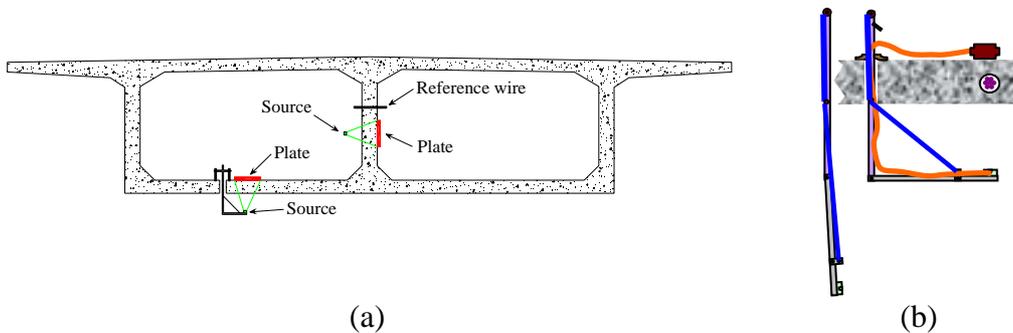
Fig. 7 - Experimental setup: (a) Bridge cross section showing the two source-plate arrangements used in this work; (b) Sketch of the tool designed to position the source beneath the bottom slab using pre-existing holes.

In Fig. 5 and Fig. 6 some of the sectors where the measurements were taken are identified. Each measurement covers an area of 45 x 35 cm, which is defined by the dimensions of the film. Sectors 1-4 and 7 are located in the bottom slab and sectors 5 and 6 in the central web. For the web measurements, thin wires inserted through existent holes were used as reference for the correct positioning of source and plate on each side of the web, as depicted schematically in Fig. 7 (a). In the case of the bottom slab measurements, an especially designed tool, see Fig. 7 (b), was used in conjunction with the existing 9 cm holes. This tool made it possible to position the source beneath the floor in a very inexpensive way when compared to the alternative of costly scaffoldings or other heavy machinery. It consists of two bars, joined with a hinge, which in its quasi-straight position (left hand side of Fig. 7 (b)) is moved down through the hole. By pulling a cable once the hinge is beyond the hole, the lower arm is lifted to reach the horizontal position depicted on the right side of Fig. 7 (b), so that the source is set facing the plate on the upper side of the bottom slab. Both the vertical and horizontal positions of the source are adjustable.
